S/2415/2025  
20 June 2025  
ENGLISH only

**NOTE BY THE TECHNICAL SECRETARIAT****REPORT OF THE TECHNICAL ASSISTANCE VISIT ON THE ACTIVITIES  
CARRIED OUT IN SUPPORT OF A REQUEST BY UKRAINE  
(TECHNICAL ASSISTANCE VISIT TAV/02/25 AND TAV/03/25)**

### REPORT OF THE OPCW TECHNICAL ASSISTANCE VISIT ON THE ACTIVITIES CARRIED OUT IN SUPPORT OF A REQUEST BY UKRAINE (TECHNICAL ASSISTANCE VISIT TAV/02/25 AND TAV/03/25)

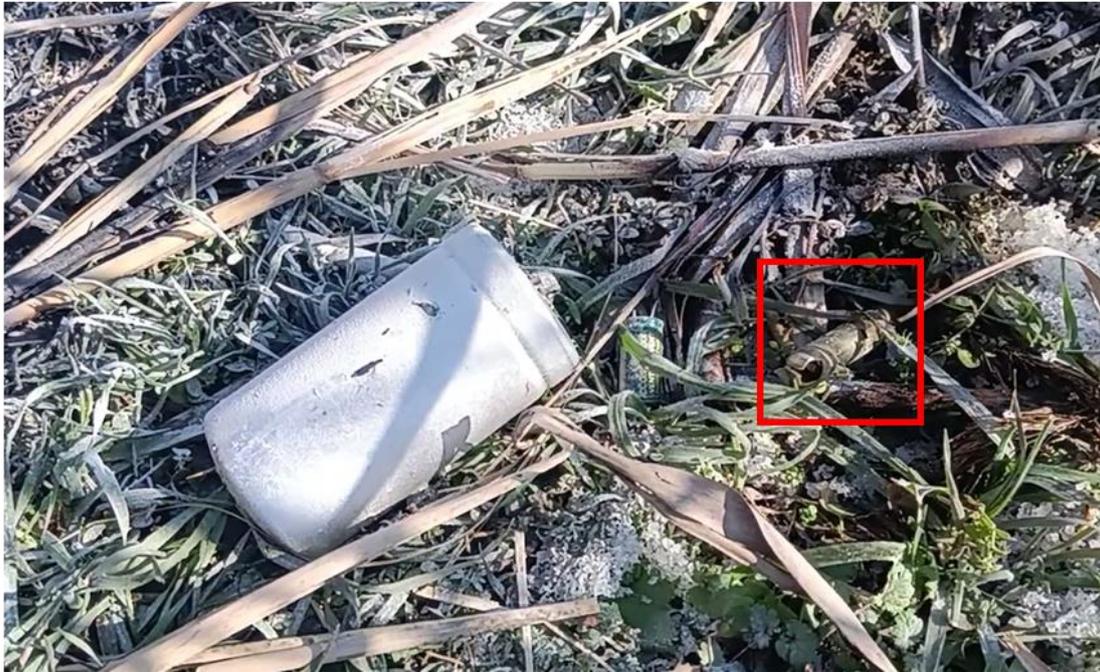
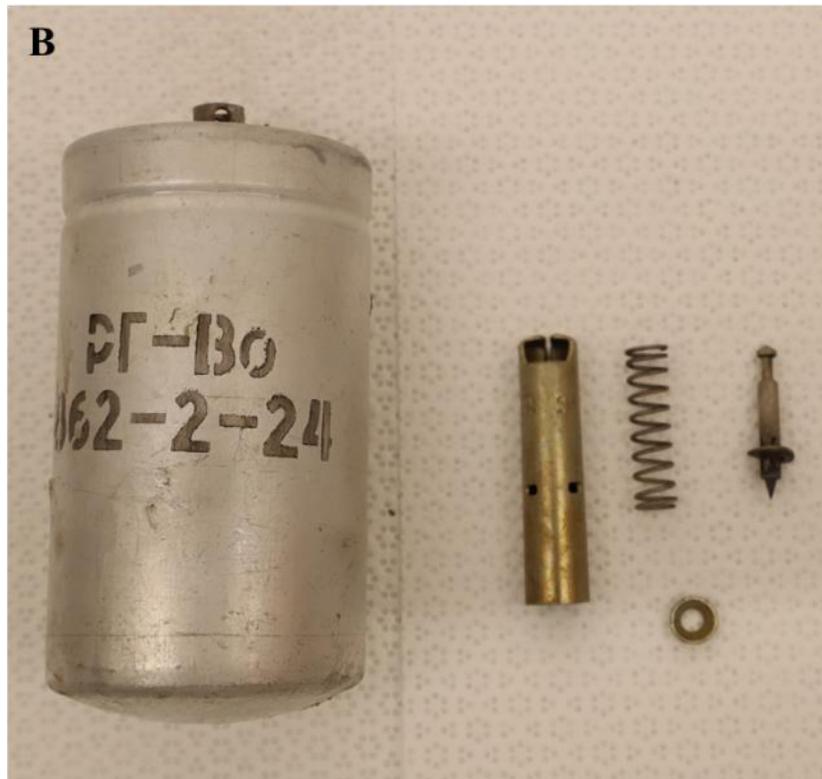
**FIGURE 2: GRENADE #1 AND PARTS OF A FUSE SYSTEM (IN THE RED RECTANGLE) AS FOUND AT THE INCIDENT LOCATION (A) AND AS HANDLED BY THE TAV TEAM AT THE OPCW LABORATORY (B).**

24. The samples received from the Ukrainian authorities during the first deployment of the OPCW TAV team consisted of:
    - (a) one grenade (Grenade #1, see Figure 2) collected with a metallic piece assembly that resembles a part of a fuse system (sample code SDS06);

30. One of the grenades appears as a silver-coloured metallic cylindrical canister; the appearance of the second one showed signs that it had been burned. From the video recordings taken during sampling activities, the environment close to Grenade #2 displayed also signs of being burned. Both grenades show indications of being deployed or activated. No fuse system was attached to either of the grenades, and the half O-ring shaped opening on the top face of Grenade #1 had ruptured and displayed some black agglomeration around it.

36. Grenade #1 (SDS06) was collected with an item that resembles parts of a fuse system. With reference to Figure 2-B and Figure 5-A, it was possible to reconstruct the collected fuse parts into the fuse system.

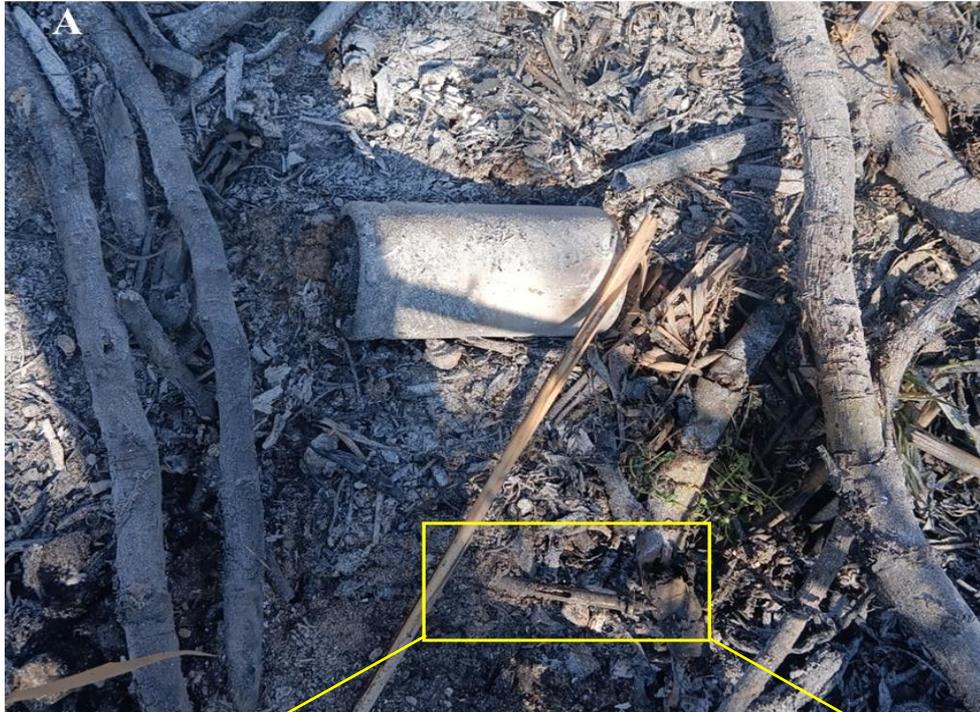
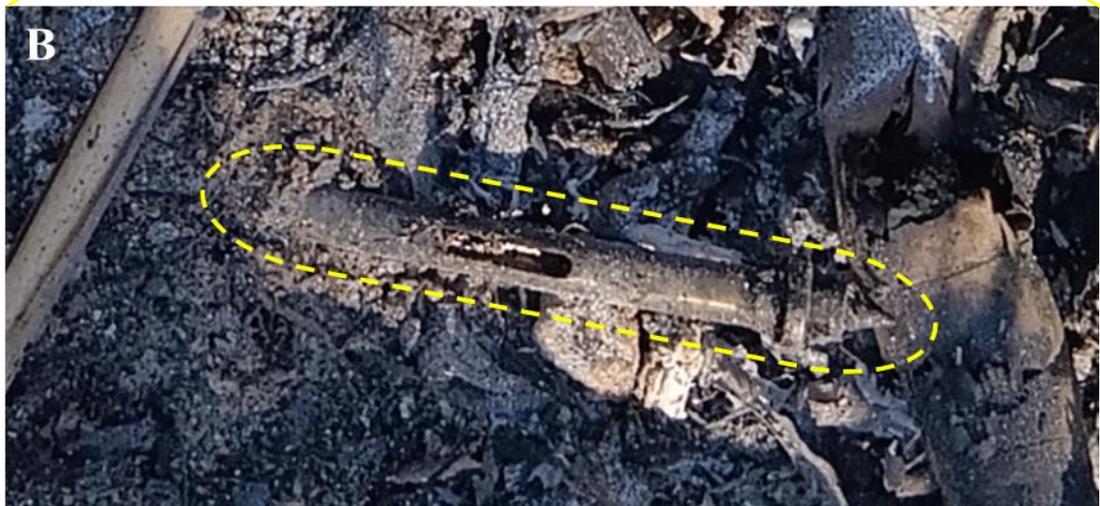
**FIGURE 3: GRENADE #2: (A) AS FOUND AND PHOTOGRAPHED AT THE INCIDENT LOCATION AND (B) PARTS OF A FUSE SYSTEM OBSERVED BY THE TAV TEAM ON THE PHOTOGRAPH.**

- (b) one grenade (Grenade #2, see Figures 3 and 4) showing signs of being burned (sample code SDS07);
    - (c) one soil sample collected close to where Grenade #2 was found (sample code SLS05);

37. When examining the photographs and video recordings received from the Ukrainian authorities, the TAV team noted that, at close proximity to the burned Grenade # 2, a second item that resembles a fuse system was laying on the ground in the burned area of the incident location (Figure 3-B). This item was not collected from the scene.

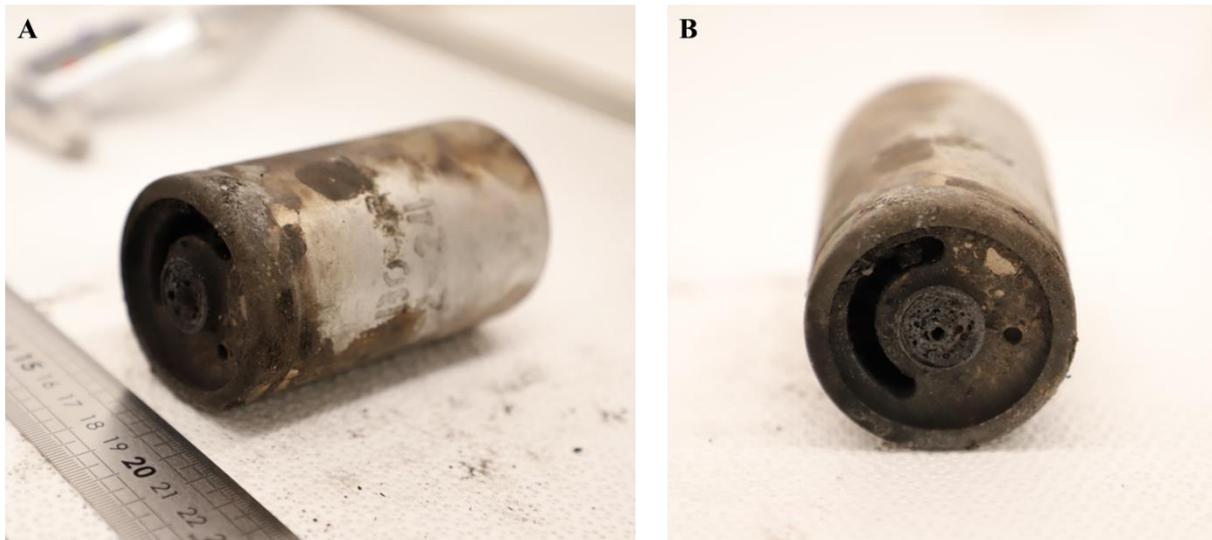
**FIGURE 4: GRENADE #2 AS PHOTOGRAPHED AT THE OPCW LABORATORY BY THE TAV TEAM. A SIDE VIEW (A)**

- (c) The collected Grenade #2 (SDS07) contained several degradation products of CS including 2-Chlorobenzyl cyanide and the precursor/degradation compound 2-Chlorobenzaldehyde. One designated laboratory reported also the presence of CS at very low levels in this burned grenade.

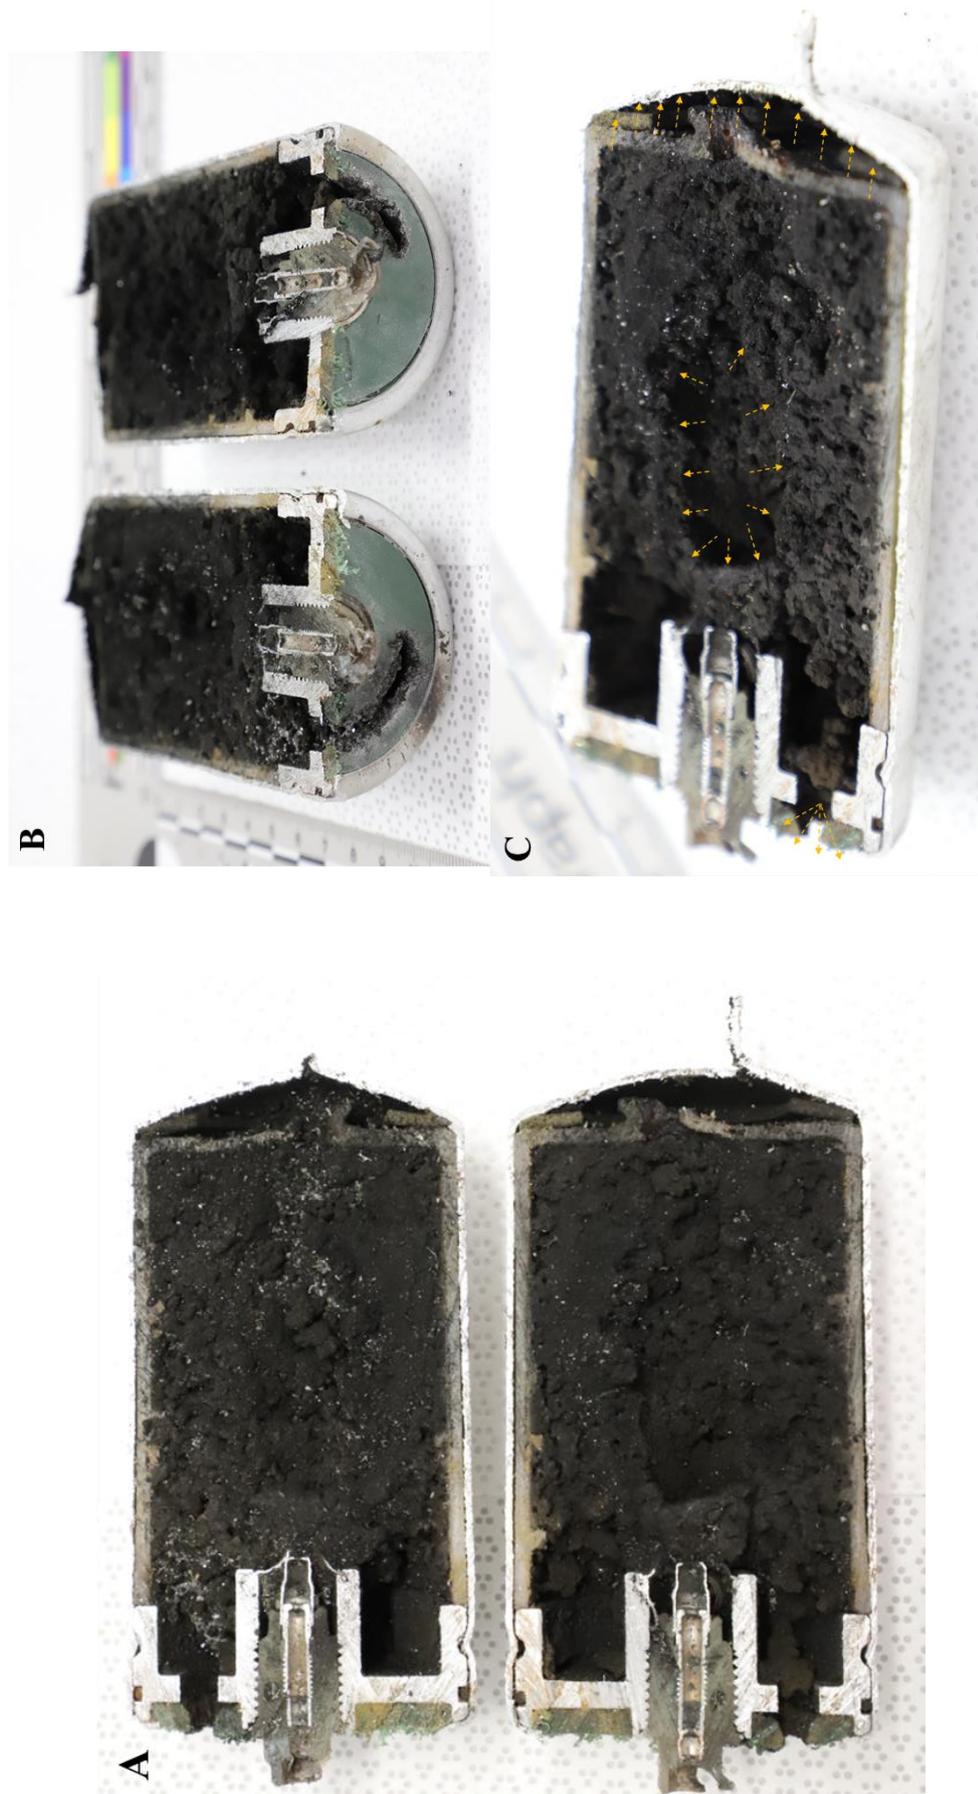
**FIGURE 5: GRENADE #1. (A): TOP VIEW OF THE LONGITUDINAL CUT. (B): SIDE VIEW AFTER THE CUT SHOWING THE TOP GREEN LID OF THE GRENADE. (C): A VIEW OF THE CUT GRENADE SHOWING THE GOUGED MIDDLE PART AND THE CONVEX SHAPE OF THE BOTTOM.**

31. The TAV team also examined the inner structure of one of the two collected grenades. At the OPCW Laboratory, the team proceeded with a longitudinal cut on Grenade #1 to further explore the inner parts of this activated grenade. Figure 5 showcases views of a longitudinal cut of Grenade #1 (SDS06).

32. The top part of the cut grenade reveals the shape of the fuse assembly and the opening in the metallic lid at the level of the half O-ring shaped opening in the green plastic lid.

33. A burned black solid substance fills the inside body of the grenade. The cut of the grenade further reveals the convex-shaped bottom of the deployed canister.

34. As visible in Figure 5-A, the cut of the grenade clearly shows the fuse assembly which consists of the igniter, the delay, and the detonator components.

35. A second structure is observed inside the silver-coloured metallic canister (Figure 5-A). It consists of: a silver-coloured metallic cylindrical part with fuse inlet and the discharge opening at the top part of the grenade; and a light grey plastic-like canister containing a burned black solid substance and a thin O-ring at the bottom of the grenade. The centre part of the burned black solid content looks gouged and the bottom part of the plastic-like cylinder is ruptured, likely as a result of the pressure increase during the detonator explosion, which also led to the convex shape of the bottom part of the outer silver-coloured metallic canister (Figure 5-C).

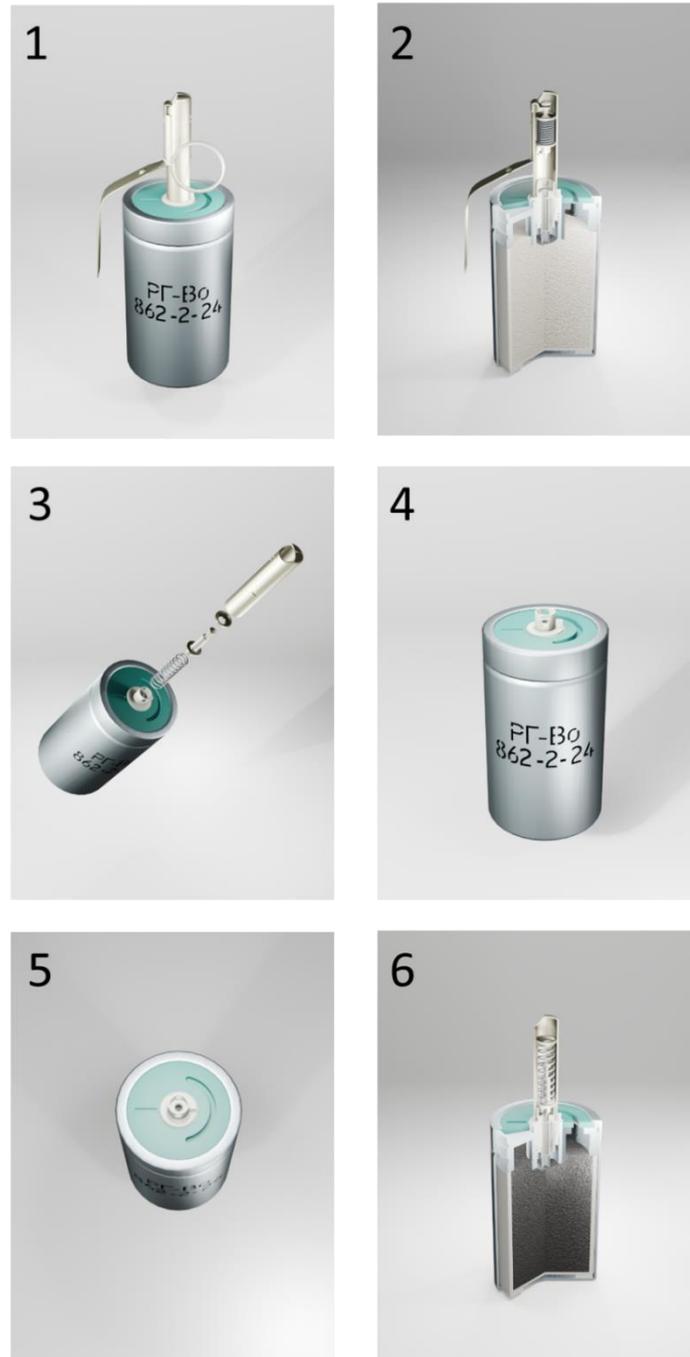
**FIGURE 6: RECONSTRUCTED MODELS OF THE GRENADES**

38. Although both grenades showed damaged parts or were missing some of the components, the TAV team was able to reconstruct a model of these grenades. This model was based on the detailed measurements of each item and its parts, as well as on the examination of publicly available data relevant to this type of grenade.
39. Figure 6 displays several sides of view of the reconstructed models with an emphasis on the parts and items relevant to the collected grenades and the fuse assembly.

(1) A view of a full, non-deployed grenade with visible markings. (2) A view of a longitudinal cut of a full, non-deployed grenade and its fuse system. (3) An exploded view of fuse assembly parts and a grenade, similar to those collected from the incident location. (4) An inclined front view of a grenade with its central plug and visible markings and without its fuse system. (5) A top-side view of a grenade showing its central plug and a half O-ring shaped indent on the green lid. (6) A view of a longitudinal cut of a deployed grenade together with its fuse system and the burned solid substance inside the canister.
